US Army Corps
of Engineers
Construction Engineering
Research Laboratory

TECHNICAL REPORT M-86/14
July 1986

Field Test Results of Aluminum Standing-Seam Roofing

by
Myer J. Rosenfield

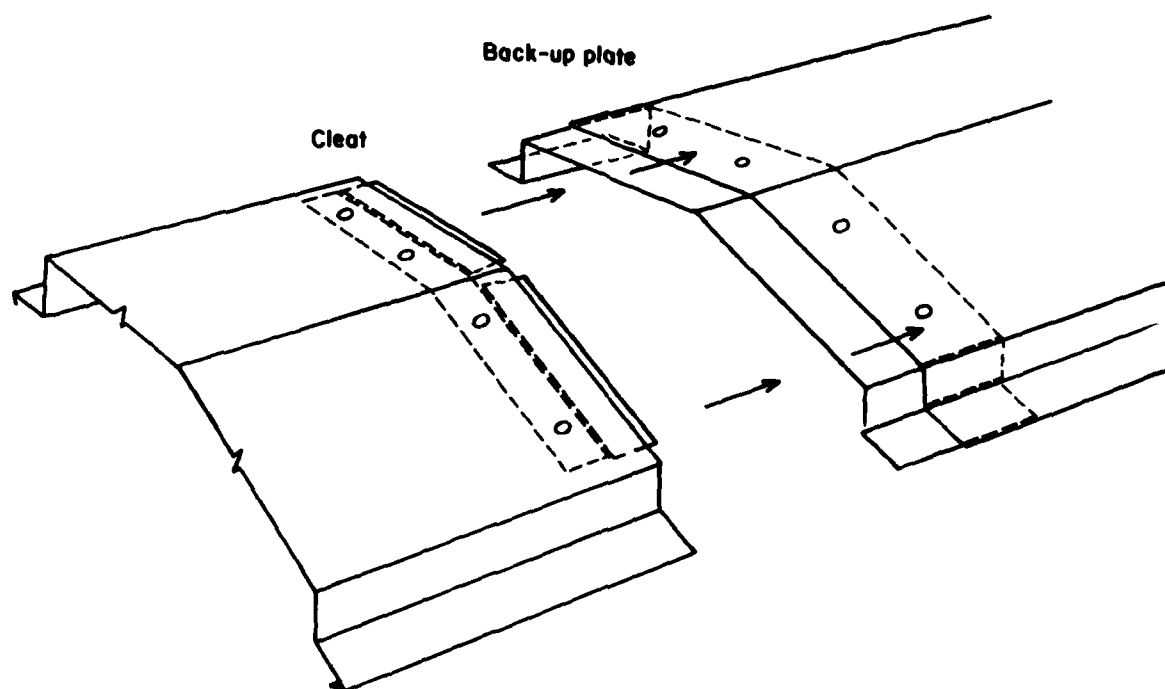
Figure 19. Manufacturer's design of ridge cap expansion joint.

Figure 18 shows a damaged expansion joint in the ridge cap. It also shows that the expansion joint was fabricated similar to the manufacturer's design, as detailed in Figure 19, but was not installed properly. A buckled flange was noted at one location on the ridge cap (Figure 20). This may have occurred during original installation rather than as a result of expansion. However, the exact cause is not known. The effect is not serious since there is already a space between the top of the panel closure and the ridge cap, which is not gasketed.

The ridge caps will be the easiest components of the roofing system to remove, repair, and replace. At the firewall ends, the ridge caps should be anchored to the walls by aluminum or stainless steel clip angles. The counterflashing could then incorporate a flange to cover the cap. Fasteners holding the ridge cap flanges to the panel closures should be removed and the holes sealed with closures similar to tinker's dams. Clip angles should be attached to the panel closures, and the ridge cap fastened to these clips through slotted holes. This recommendation is illustrated in Figure 34. Ridge cap expansion joints should be checked to determine if they are free to slide, and comply with the manufacturer's recommendation (Figure 19).
